Riser & Conductor Engineering

Understanding Conductor Integrity and Extending Life of Jacket Platforms

Christopher Li
14th March 2019

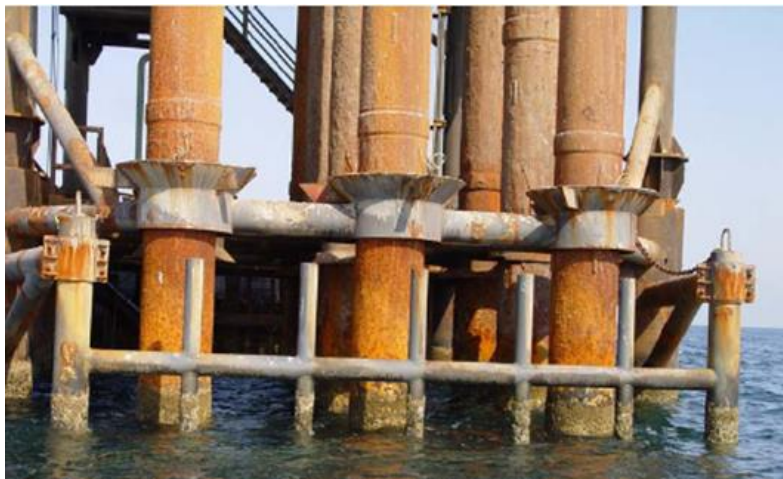
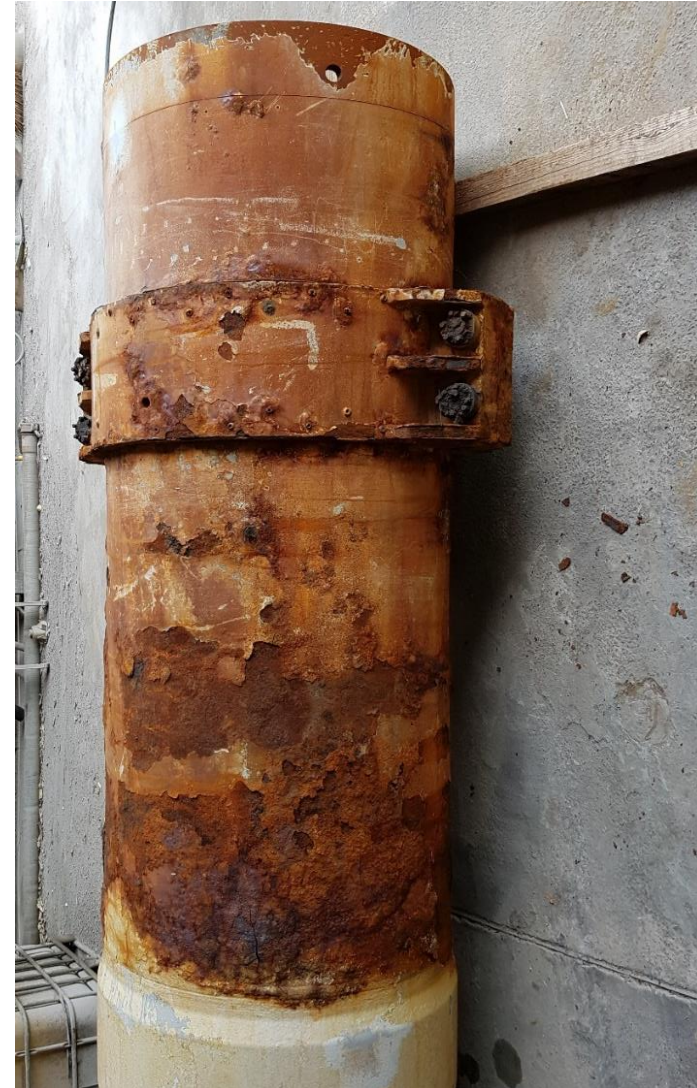
Case Study #1 – Corrosion

- Corrosion observed on several conductors
- Each well assessed using measured wall thickness for corresponding well loads
- Stress utilisation exceeds allowable in corroded sections

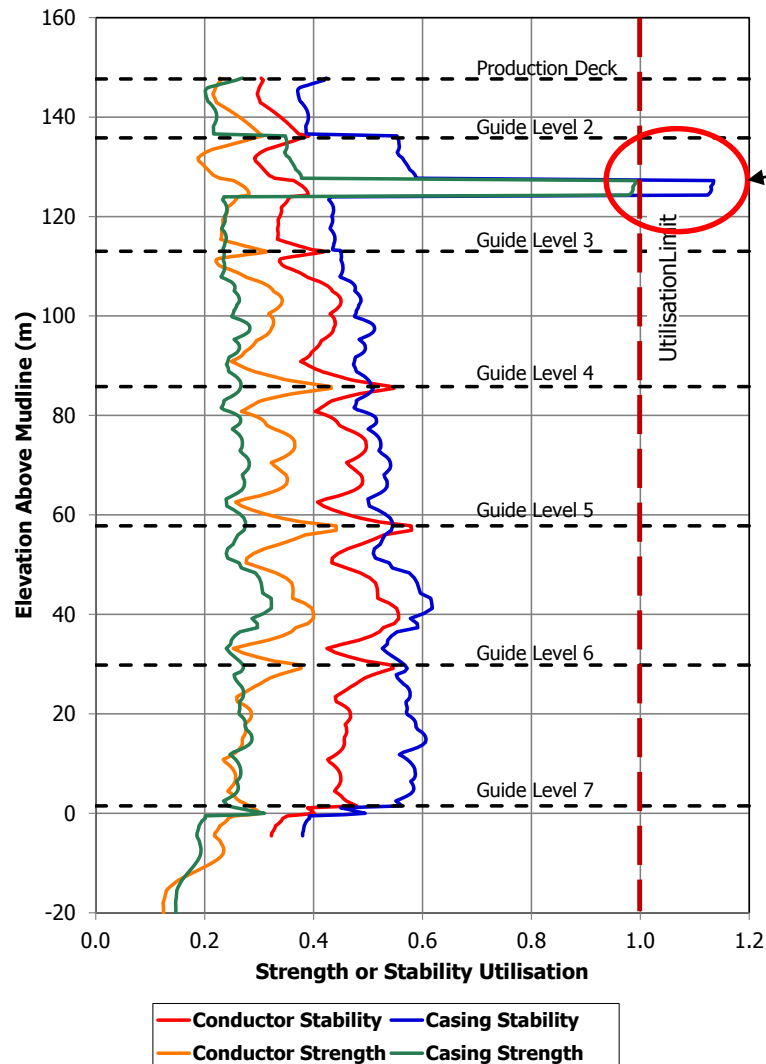
STRENGTH & STABILITY

Strength and stability utilisation exceeded in cyclonic storm condition or earthquake

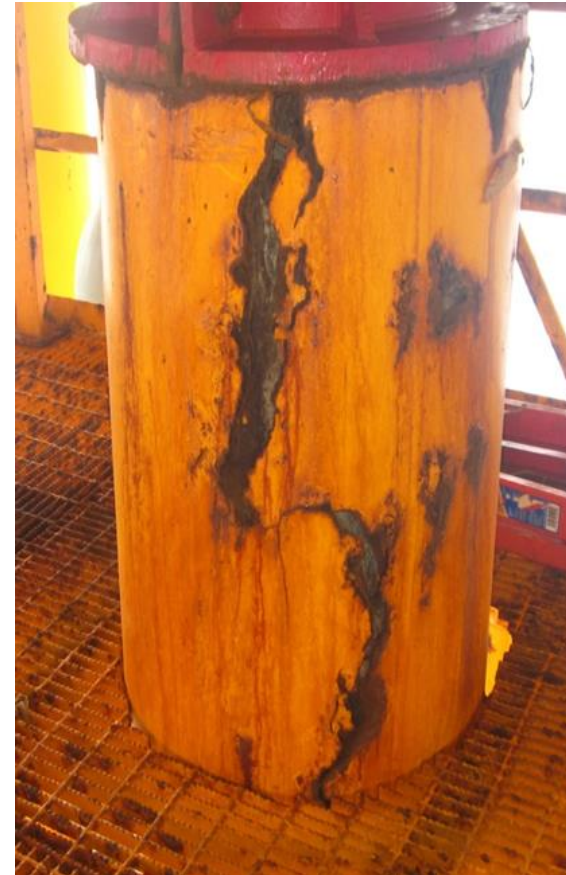
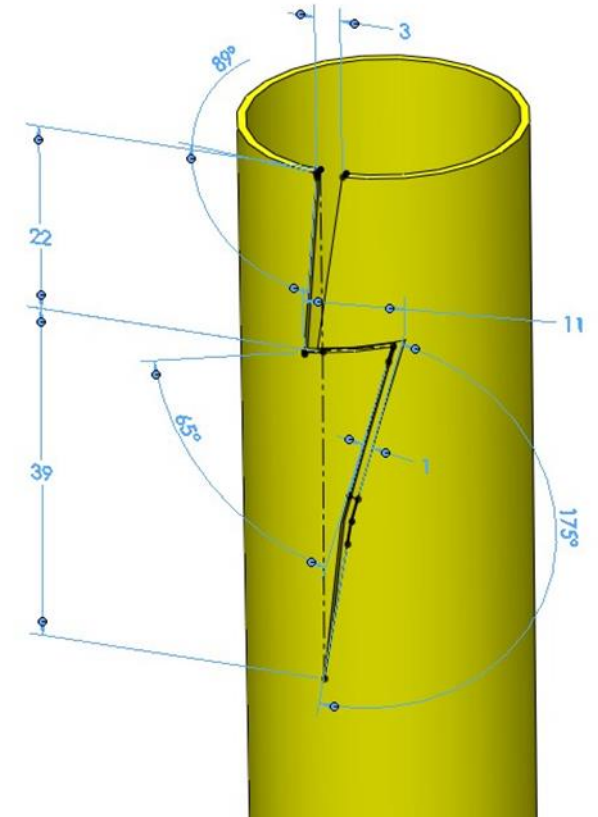
Case Study #2 – Conductor Crack Repair

- Crack on conductor above sub-cellar deck observed
- FEA Model Analysis
- Sleeve repair to prevent crack propagation

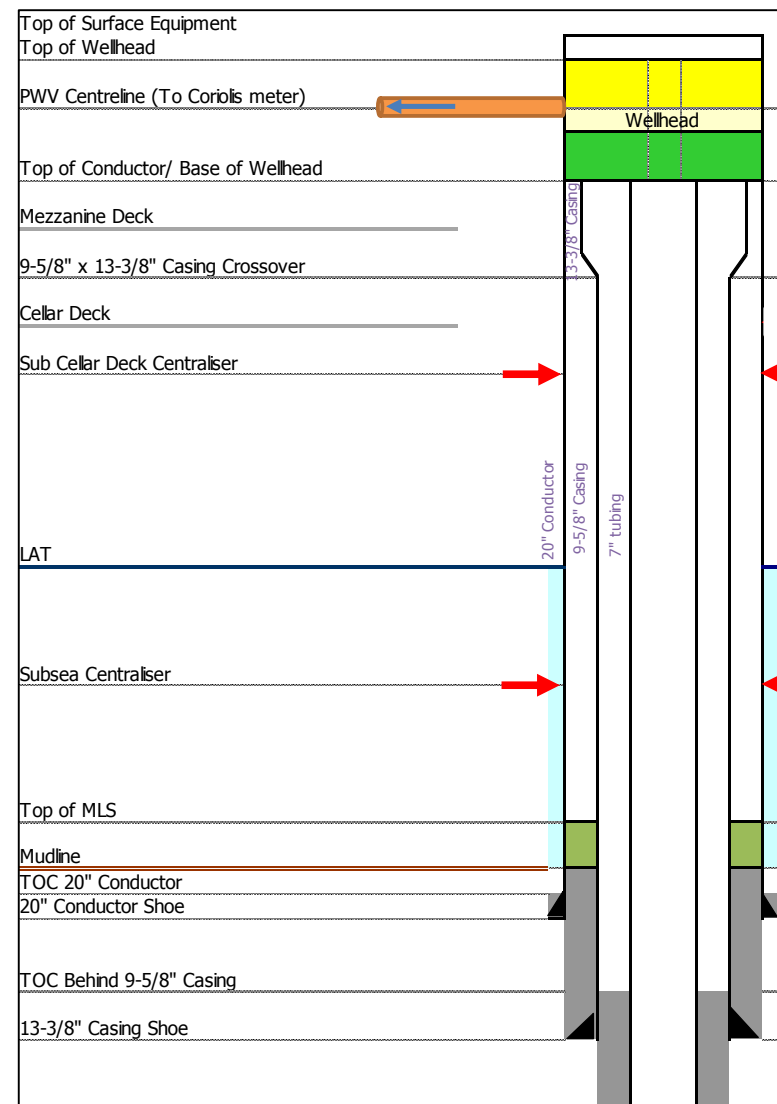
Case Study #3 – Loss of Centraliser

- Reduced conductor lateral support at sub-cellar deck
- Lateral motion of 20" conductor observed causing crack in production flowline weld
- Significant reduction in fatigue life with no centraliser around conductor
- Mitigation: retrofit centraliser

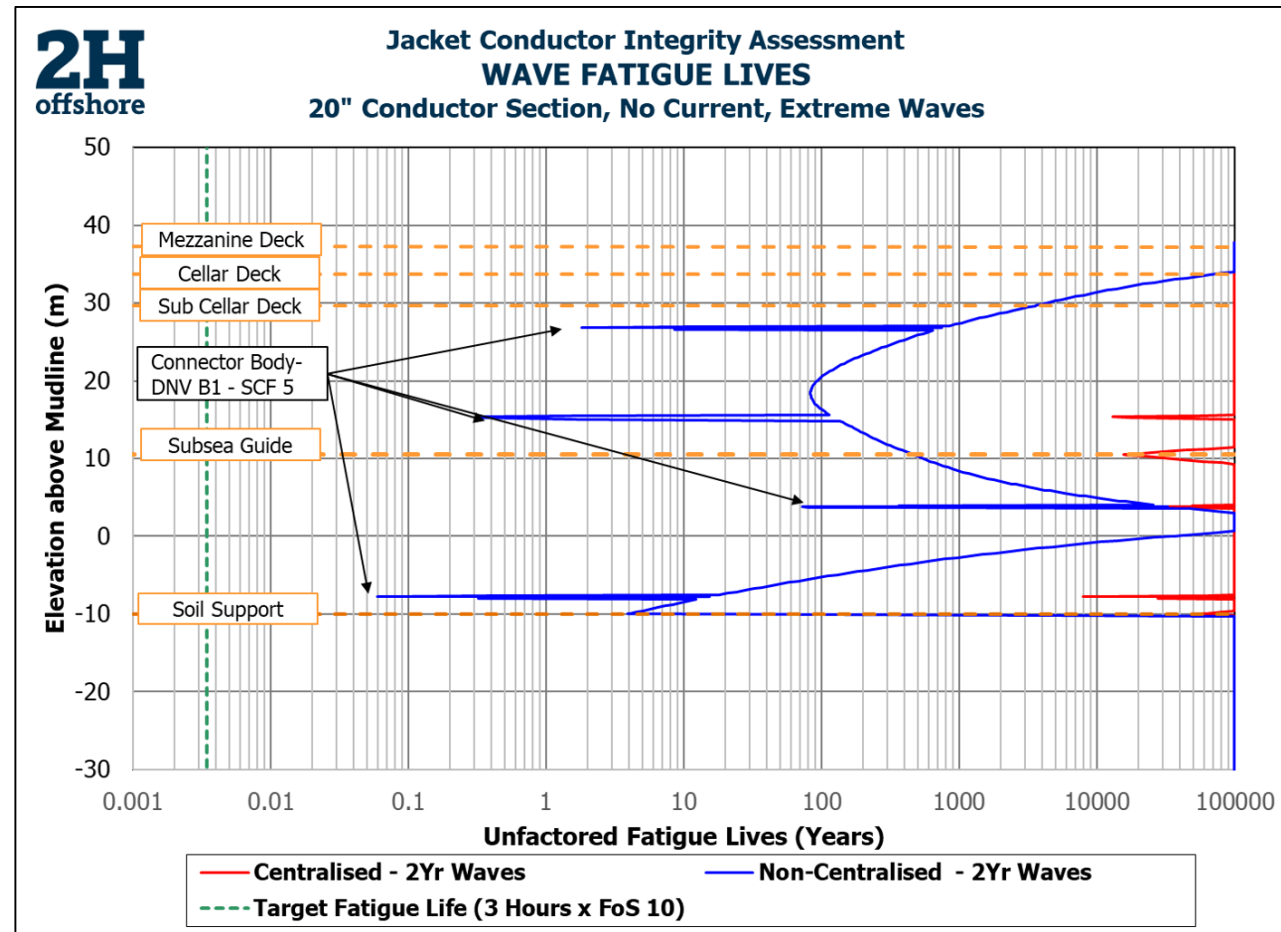
Case Study #3 – Loss of Centraliser

With no centralisers, conductor fatigue life 5 x more severe

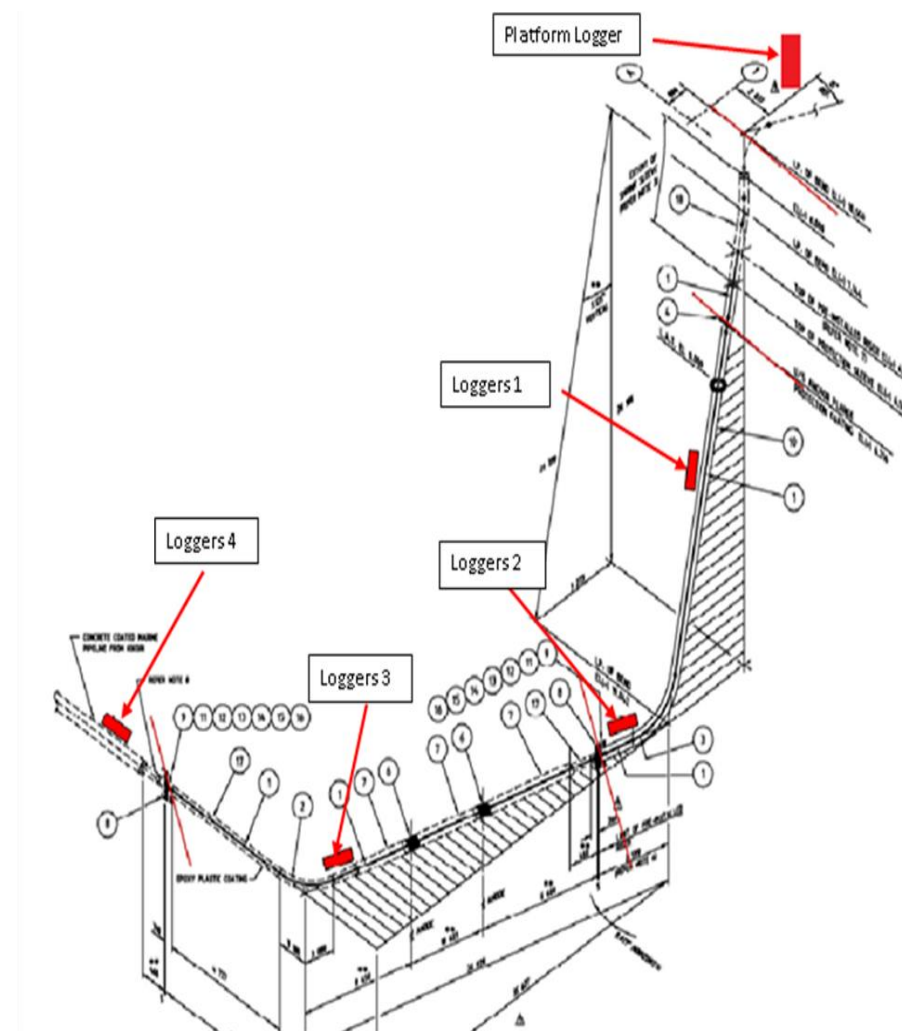
Case Study #4 - Earthquakes

- Hardwired real-time motion monitoring on jacket platform
- Monitors installed to check for VIV or wave-induced fatigue
- 2 severe earthquake events - Requirement to assess motions of system
- Recorded displacement due to earthquake loads are 17 x higher than wave loads

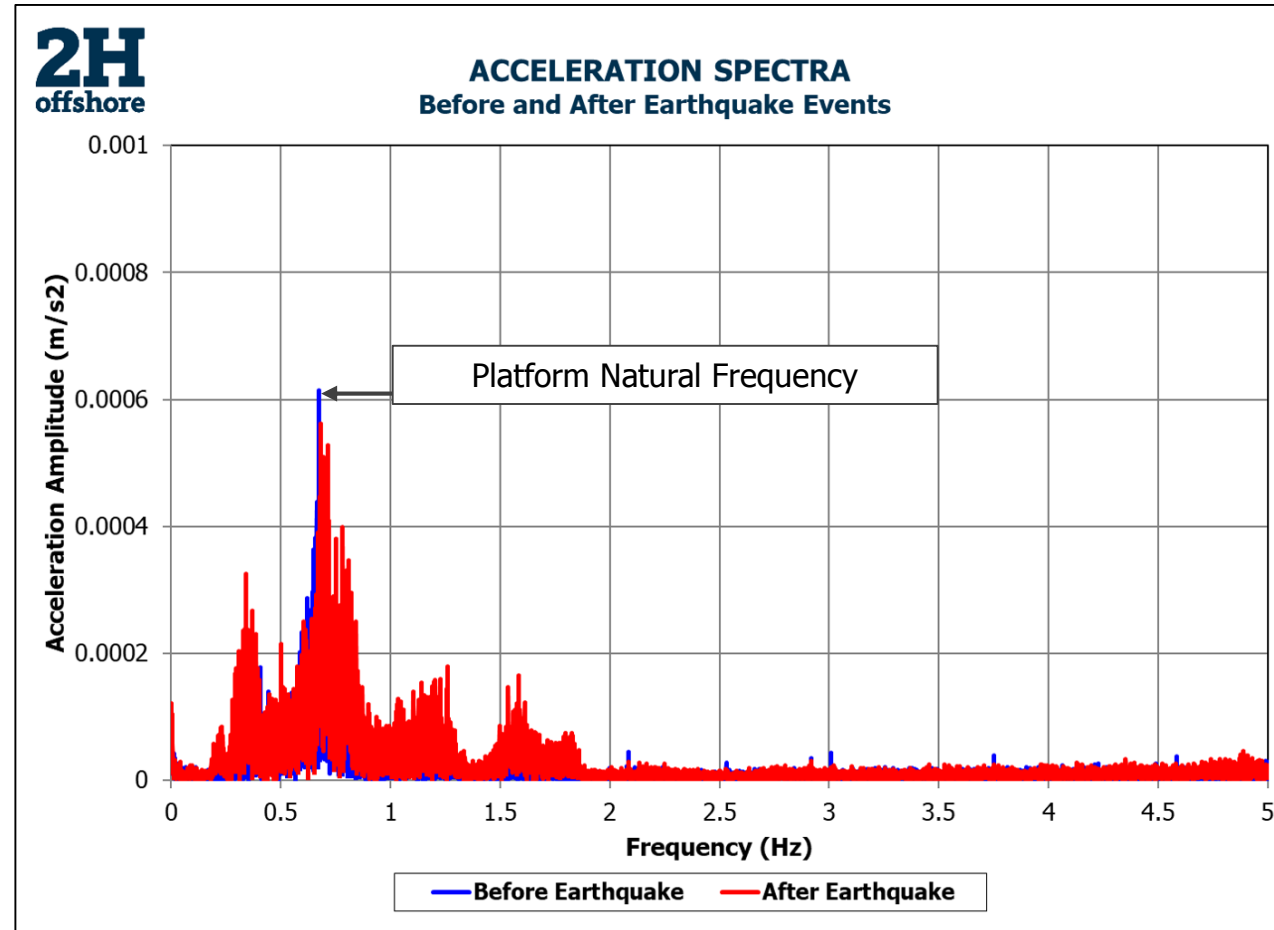
Case Study #4 - Earthquakes

Platform natural frequency did not change pre and post earthquake
