Quantitative Short Range (QSR):

Latest technology for Inspection of Corrosion Under Pipe Supports (CUPS)

AOG 2019 App

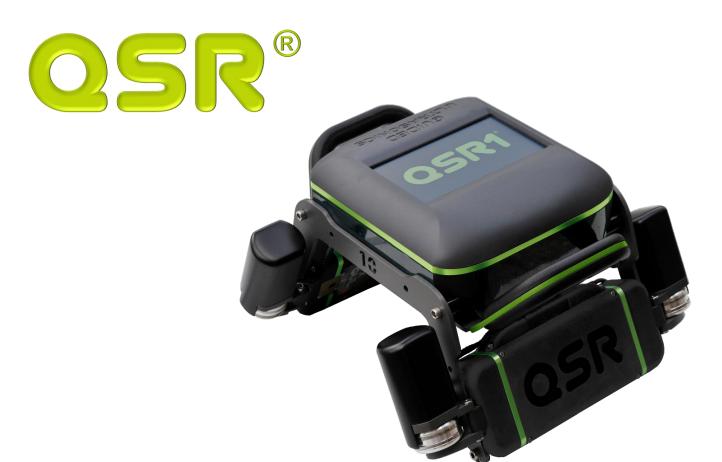
Industry Challenge: CUPS

- Typically where water collects
- Mostly hidden when in service
- Older pipes can be obscured with multiple paint layers
- Large patches can burst before there is a leak

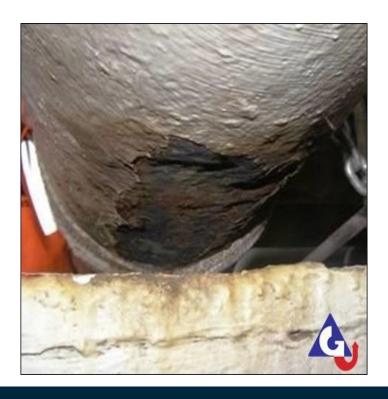
- Normally direct access through lifting, is used to measure depth
- Cost of lifting, manpower, rigging, scaffolding etc.
- Increased risks undertaken, to sometimes unknown condition of remaining wall

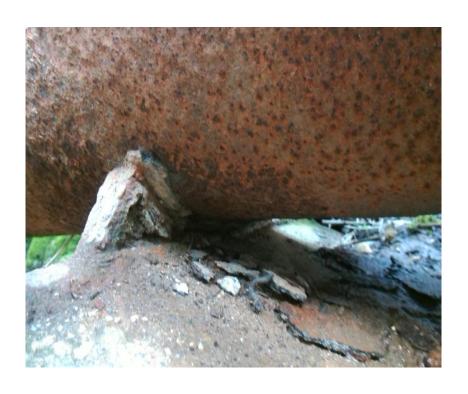
Visual Inspection.

- Line lifts required for measurements
- Guidelines for CUPS inspection management.
 Not reliable due to history of false calls. (EI)

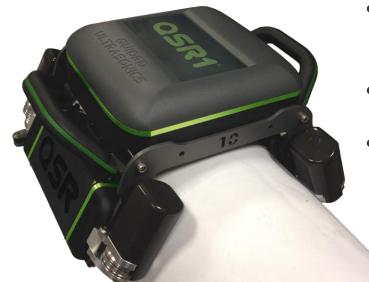
QSR1® - "Quantitative Short Range" Scanning

GUL developed system to quantitatively measure corrosion at support locations.

- Scans the pipe along the top under its own power
- Does not require couplant
- Inspection is possible through thin coatings

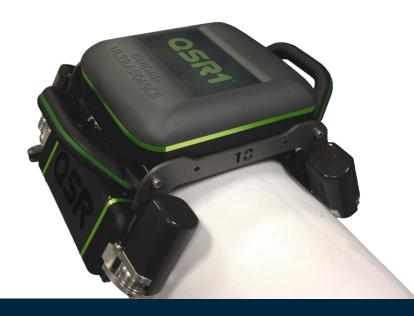
QSR[®]

8" to 24" (200 mm-610 mm) Diameter Pipe

Interchangeable Frames

6 mm to 13.5 mm Nominal thickness

LAN or USB Cable Connection

Horizontal Pipe and Simple beam supports

Smooth Surface Coating Thickness <1 mm

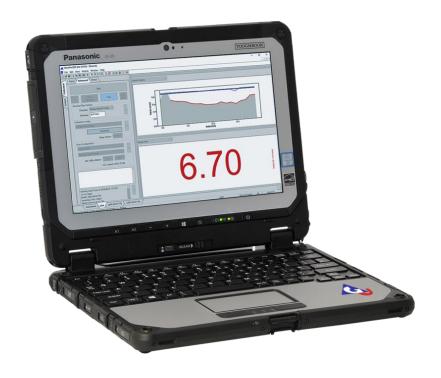
WaveProQSR™ Software

Multiple Connection Interfaces

Semi-Automated Analysis Routines

Expect Software Updates

Cloud Computing

*Cloud based analysis, machine learning and remote auditing assists with providing the best possible service

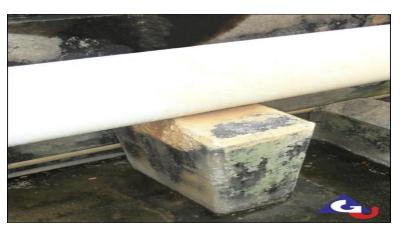
Support Types

- Simple Supports
- Pipes resting on beams

- Saddle Supports
- Circumferential Grooves
- Clamp U-Bolt
- Welded Supports

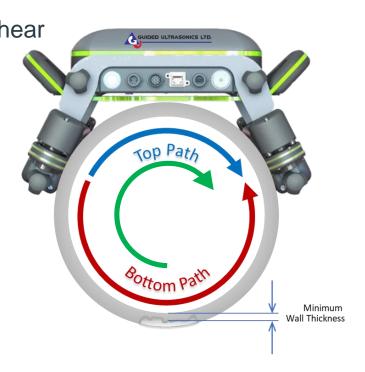
QSR Technology

Using both Dispersive and non-Dispersive Shear Horizontal wave modes, QSR1® can automatically measure at each location:

- Pipe Diameter
- Top & Bottom Path Wall Thickness
- Bottom Path Minimum Wall Thickness
- Quantitative up to 50% wall loss
- Qualitative at greater than 50% wall loss

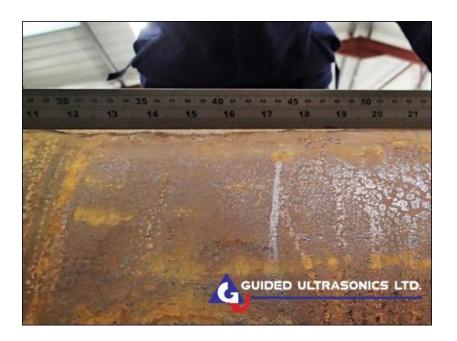
Verification: Laboratory Test

- Ex-service 12-inch pipe
- Hidden Corrosion Under Pipe Support (CUPS) type defect
- Scanned with QSR1® in order to obtain the corrosion profile
- Defect was then visually examined and laser scanned
- QSR1® scan was compared with the reference laser scan

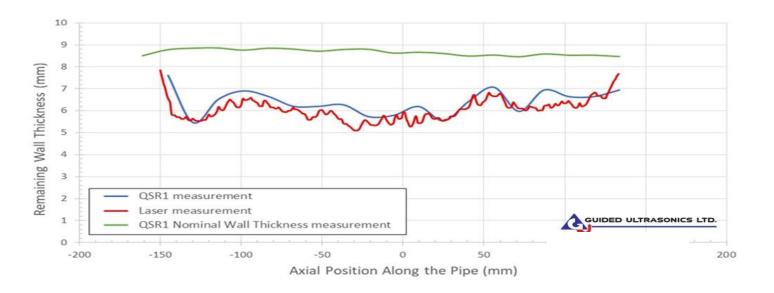
Verification: Laboratory Test

Very good agreement was achieved between the laser scan of the defected area (red line) and the QSR1® measurements (blue line).

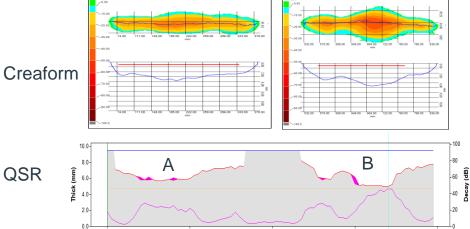
Verification: Sample Test

Ex-Service 10" QSR data compared to Creaform Laser scanner

Area	QSR (loss from meas.)	Creaform (loss)
Α	3.8 mm	3.81 mm
В	4.5 mm	4.68 mm

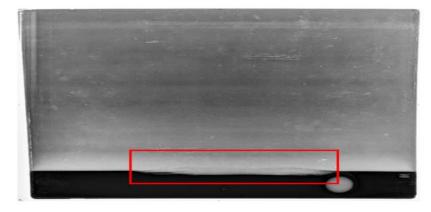
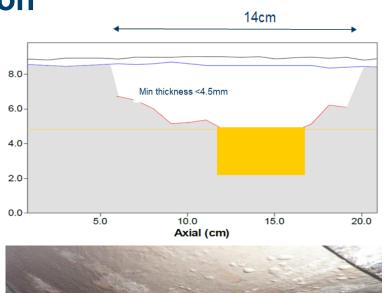
Verification: On-Site Inspection

12" In-service pipe support.

- QSR: Remaining thickness < 4.5 mm
- Rad: Estimate 4-5 mm (After pipe support removal and re-siting)

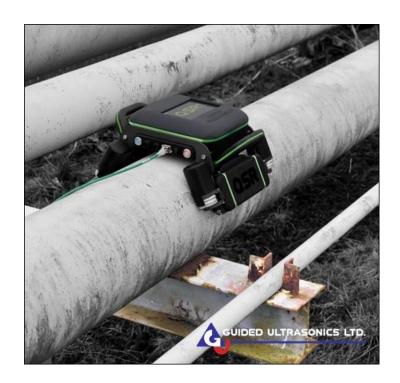
- Wide deployment to our Australian clients
- Incorporated into CUPS inspection management programs
- Oceaneering tried and test procedures
- First to introduce and utilise the innovative technology in Australia
- The only experienced and fully certified QSR operators in Australia
- QSR cloud based analysis, machine learning and remote auditing
