CURTIN CORROSION CENTRE

The Chevron and Woodside Chair in Corrosion Story.

Mariano Iannuzzi, Sofia Hazarabedian, Kod Pojtanabuntoeng, and Andy Viereckl.

15 March 2019

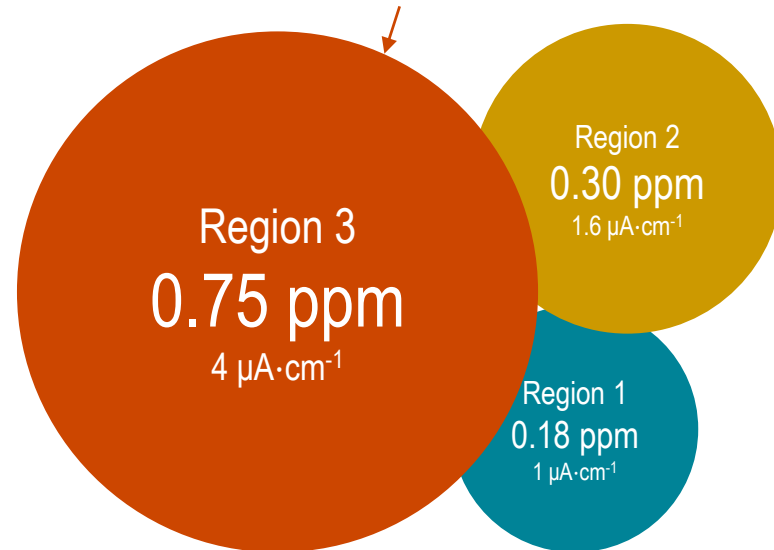
In **O&G environments**, **H₂S** acts as a **hydrogen recombination poison**, the **amount of hydrogen** entering the **steel** by corrosion at the open circuit potential (E_{OC}) in a sour environment is **much higher** than, e.g., that caused by the **external cathodic protection** system.

The sub-surface H concentration in the lattice and trap sites (C_{OR}) was found to be >70 times higher in the presence of H₂S than in samples cathodically polarized to -1.1 VAg/AgCl in seawater.

Cathodic protection

Seawater @ -1.1 V_{Ag/AgCl}

$$D_{EFF} \approx 7 \cdot 10^{-6} \text{ cm}^2 \cdot \text{s}^{-1}$$

$$J_{SS} \cdot L = D_{EFF} \cdot C_{OR}$$

Sour service

5% NaCl + 0.5% CH₃COOH pH = 2.7 @ E_{OC}

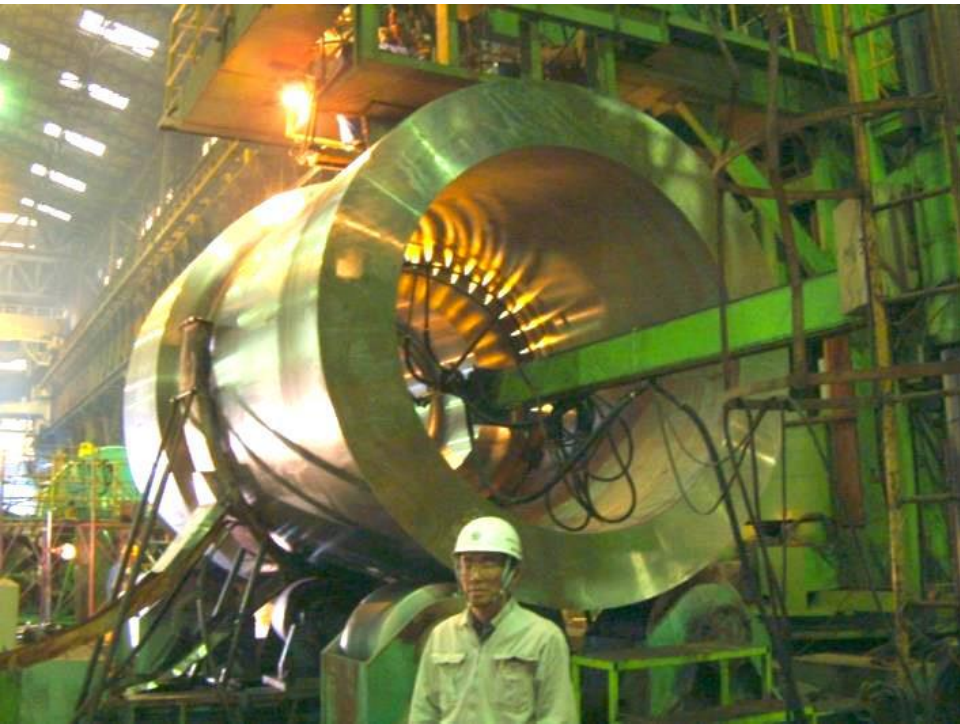
Example of a **128 ton component** made from **ASTM A508 Gr. 4N**.

Girth welding operation!

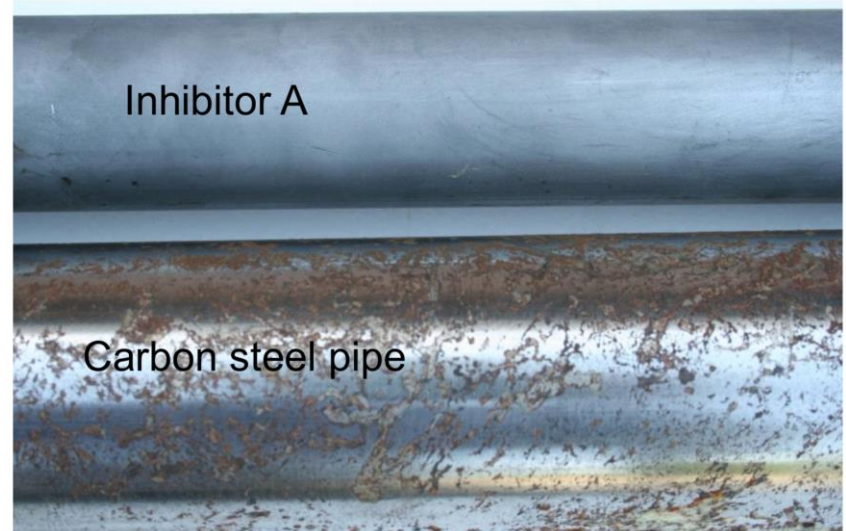
Volatile corrosion inhibitor.

5 days test duration. 8h@45°C + 8h@25°C.
20 mL 200 ppm NaCl solution every 48 h

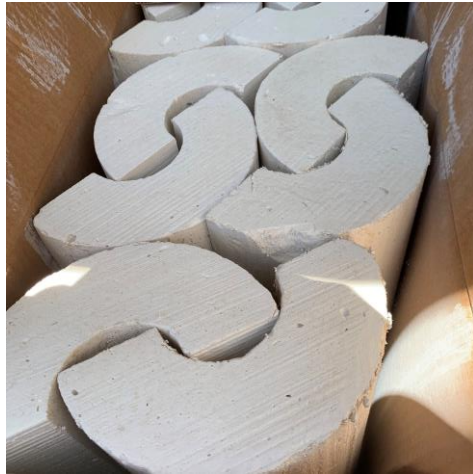
Silicate-containing insulations
(Calsil, Expanded perlite).

pH neutralizing
effects

Precipitation of
 $\text{Fe}_2(\text{SiO}_3)_3$

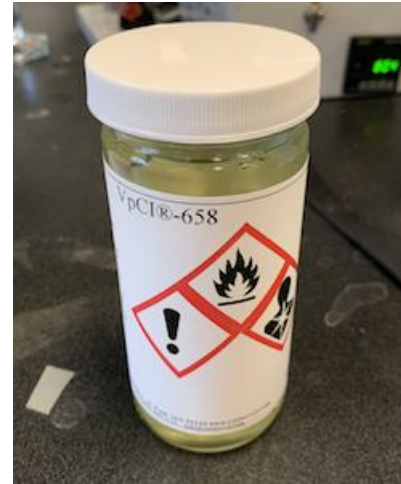
Volatile corrosion inhibitor.

Film forming
corrosion inhibitor
(Alkyltriazole)

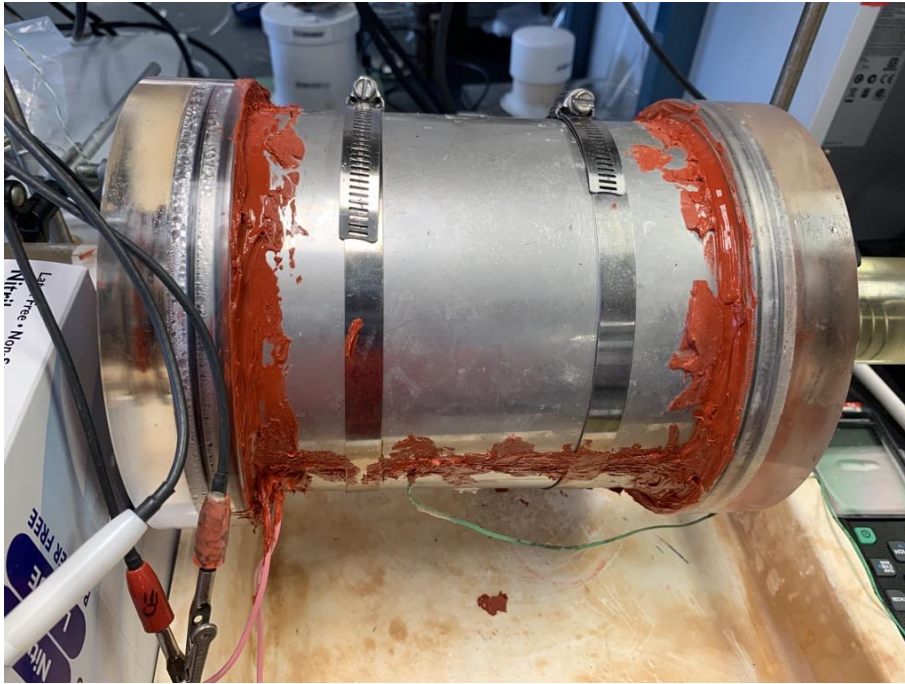
Preliminary tests were conducted at 80°C pipe temperature, mineral wool insulation saturated with synthetic seawater.

Test duration: 7 d

Assessment: Electrochemical noise technique (sampling frequency 2 and 5 Hz).

Potentiostat and Zero Resistance Amperemeter.
