TESTING AND HISTORY OF COMPOSITE REPAIR SYSTEMS FOR SUBSEA PIPELINE REPAIR

Matthew Green & Shann Ching Liew
Neptune Research, Inc.

AUSTRALASIAN OIL & GAS
EXHIBITION & CONFERENCE
11-13 MARCH 2015
PERTH CONVENTION EXHIBITION CENTRE

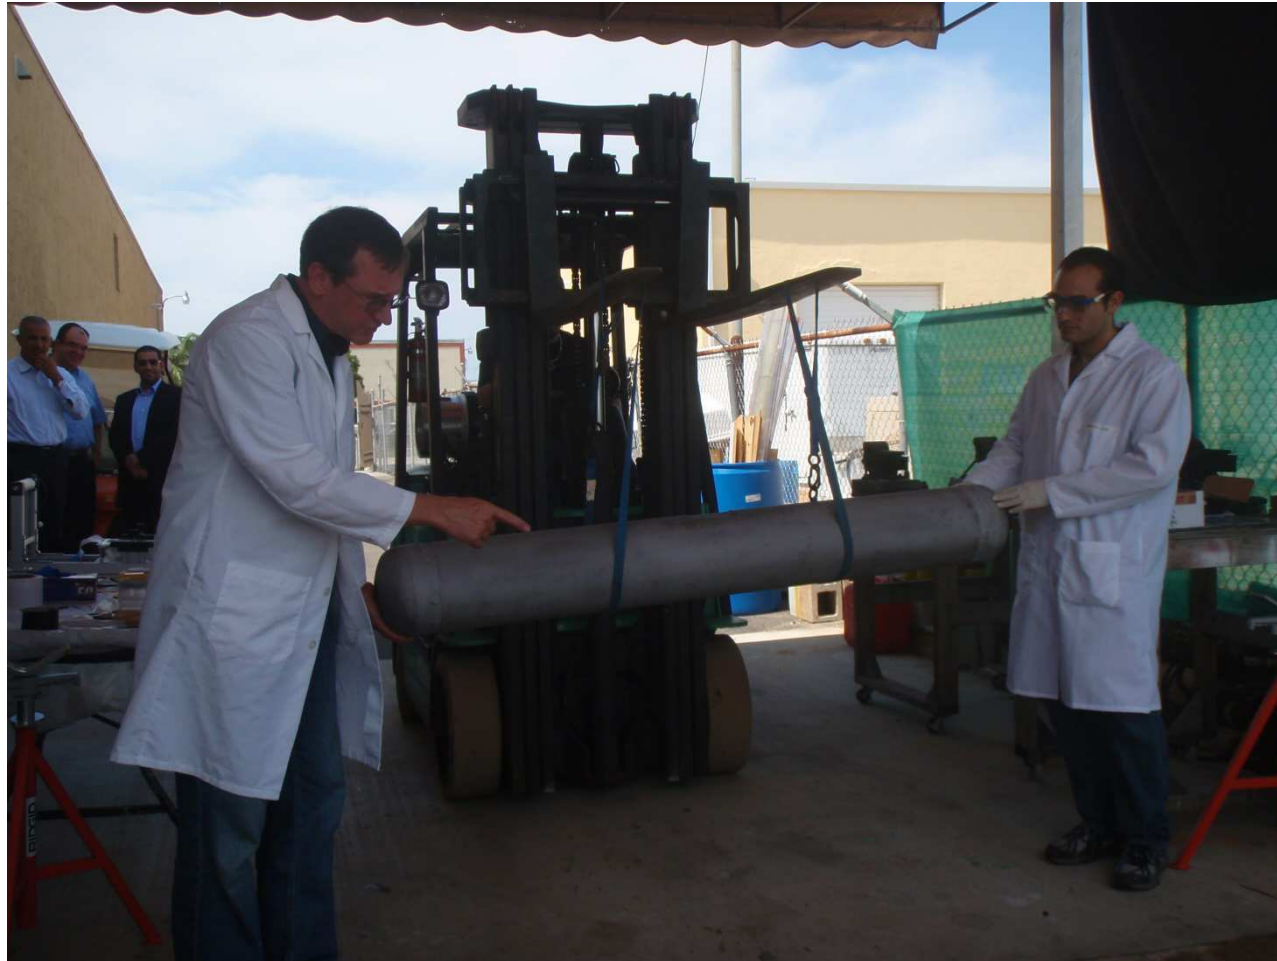
Specimen Creation

- An internal wall loss defect was to be manufactured into a pipe section and repaired using composite materials
- The pipe specifications:
 - 8" diameter
 - API 5L X65
 - Pipe length approx. 6 feet
 - Domed end caps
 - Weldolets for pressurization

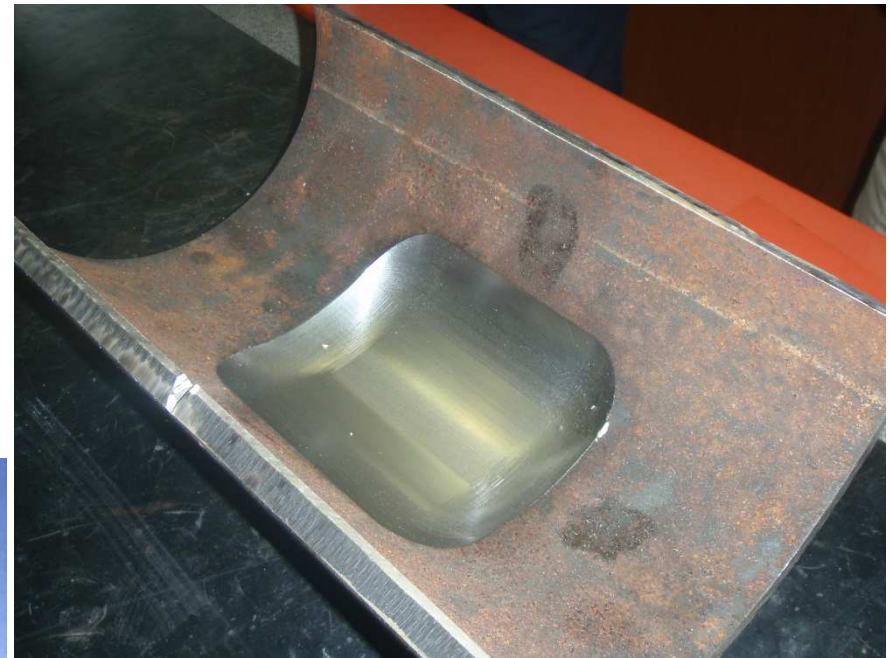
Specimen Creation

- Internal defect was machined in a section of the pipe
- Once machined to specifications of 78-80% wall loss, it was welded back into the pipe section
- In addition, another pipe was created for testing with no composite wrap

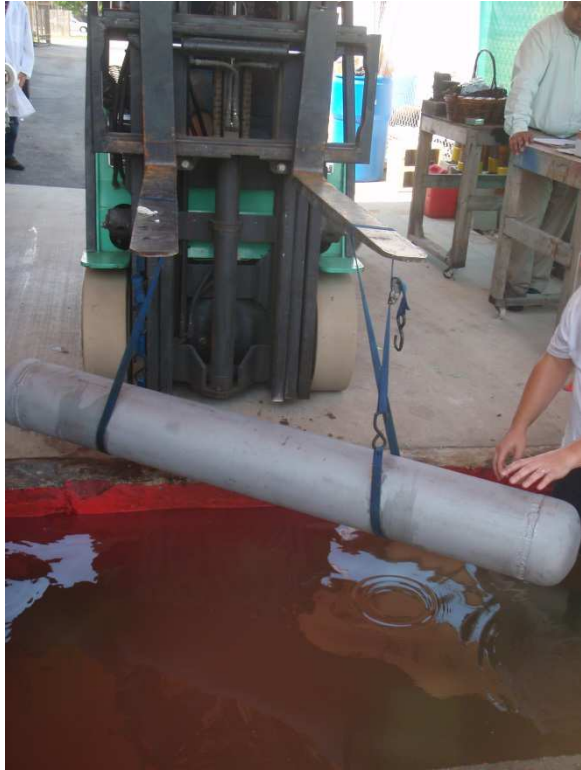
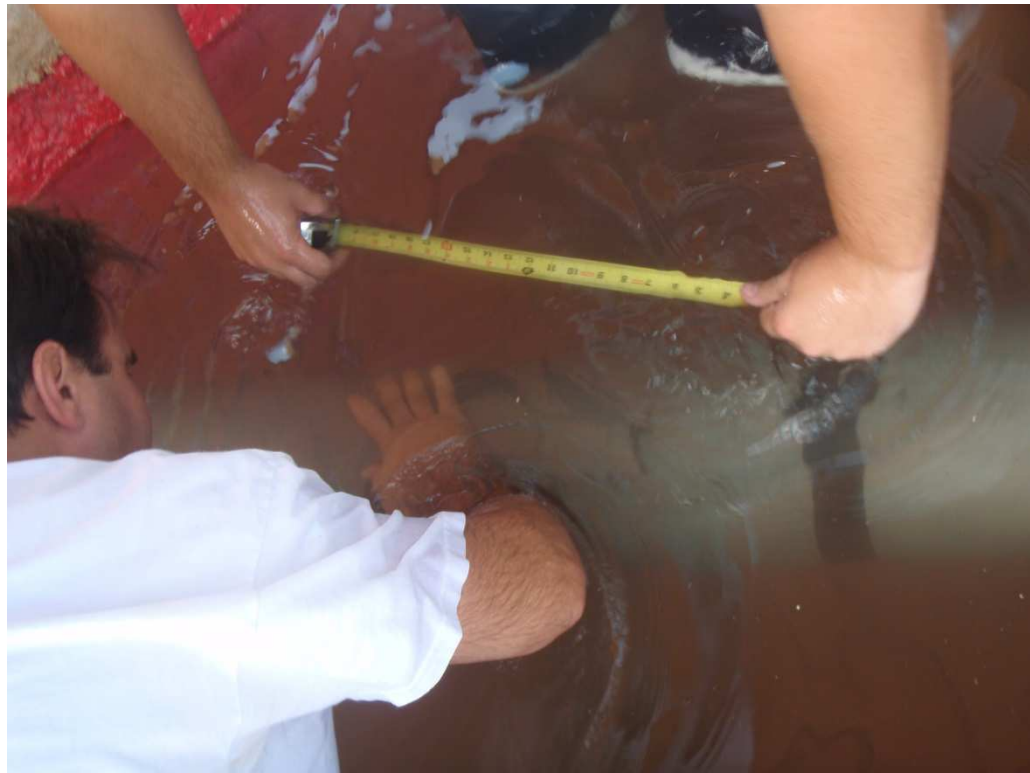
Specimen Creation

- Once prepared, the pipe was then placed into a tank of simulated sea water
- The specimen was wrapped with composite material after submersion to reflect subsea application
- Material was designed as per industry codes and standards
- Once wrapped, it was left to sit in the solution for 7 days (similar to a chemical soak test)

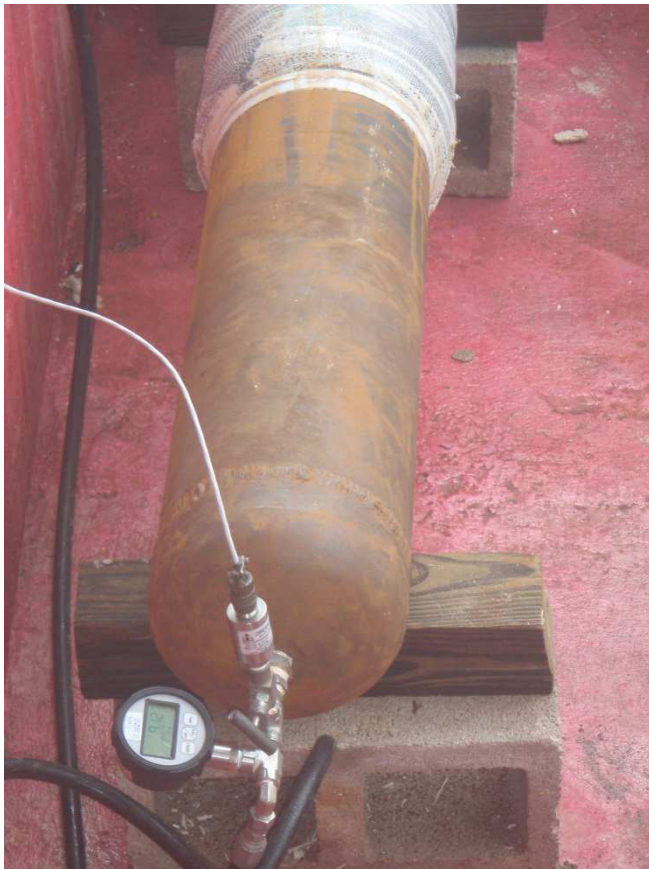
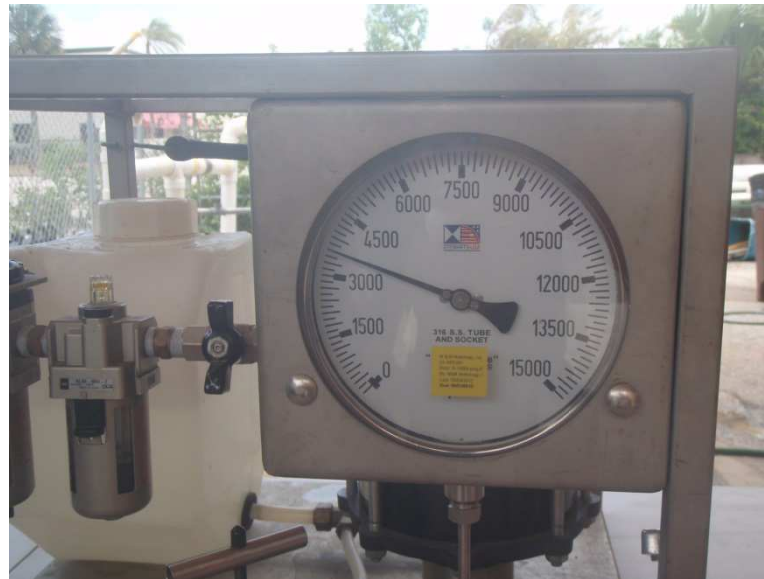
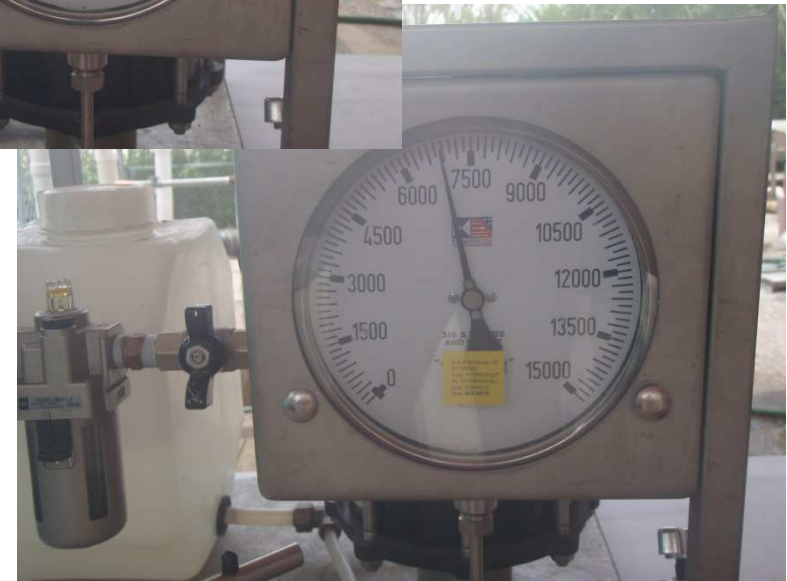
Test Results

Pressure	Time	Observations	Result
3,500 psi	30 min.	No failure or change in properties was identified	Pass
6,000 psi	30 min	No failure or change in properties was identified	Pass

- Pressurization rate of approximately 1,000 psi per minute
- Pressure held at 3,500 psi for 30 minutes
- Pressure held at 6,000 psi for 30 minutes
- The repair was observed during the pressure testing phase to note any change or failure

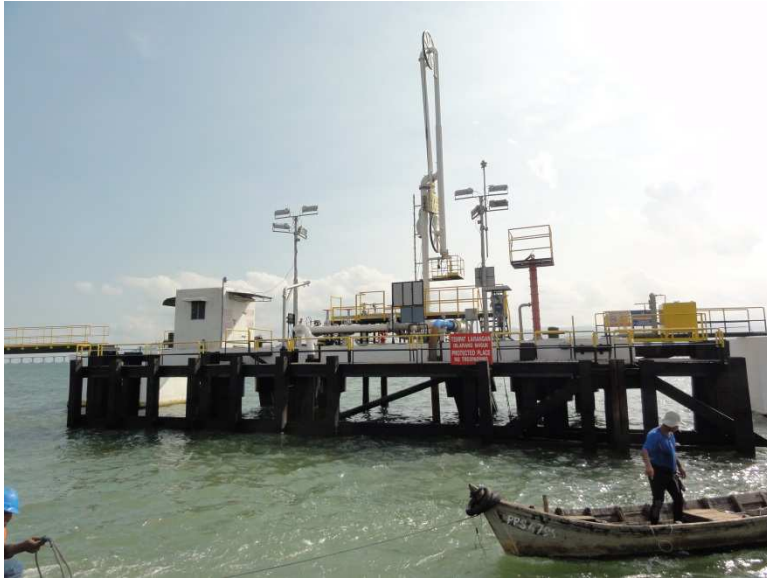
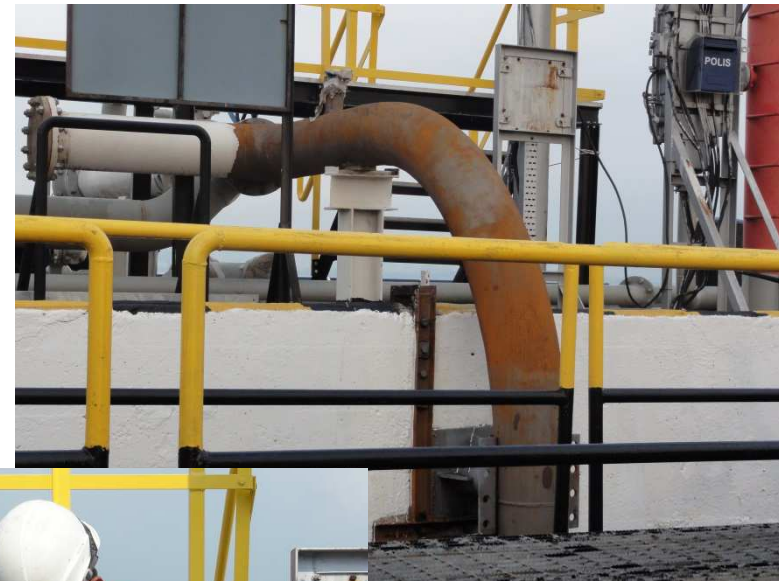
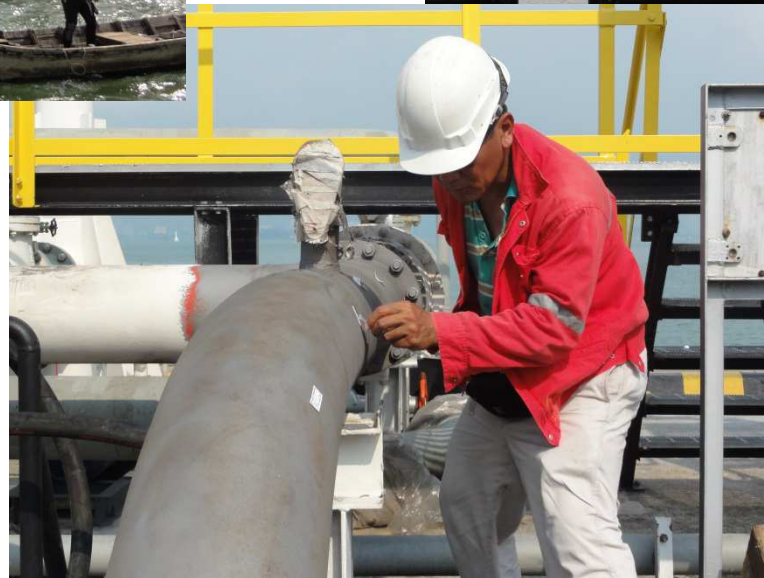
Field Case Studies

- Offshore gasoline pipeline in Malaysia
- 10" carbon steel
- 28 linear meter total repair
- Multiple defect locations with majority subsea
- Operating pressure of 800 psi
- Fully repaired via Syntho-Glass® XT composite repair system

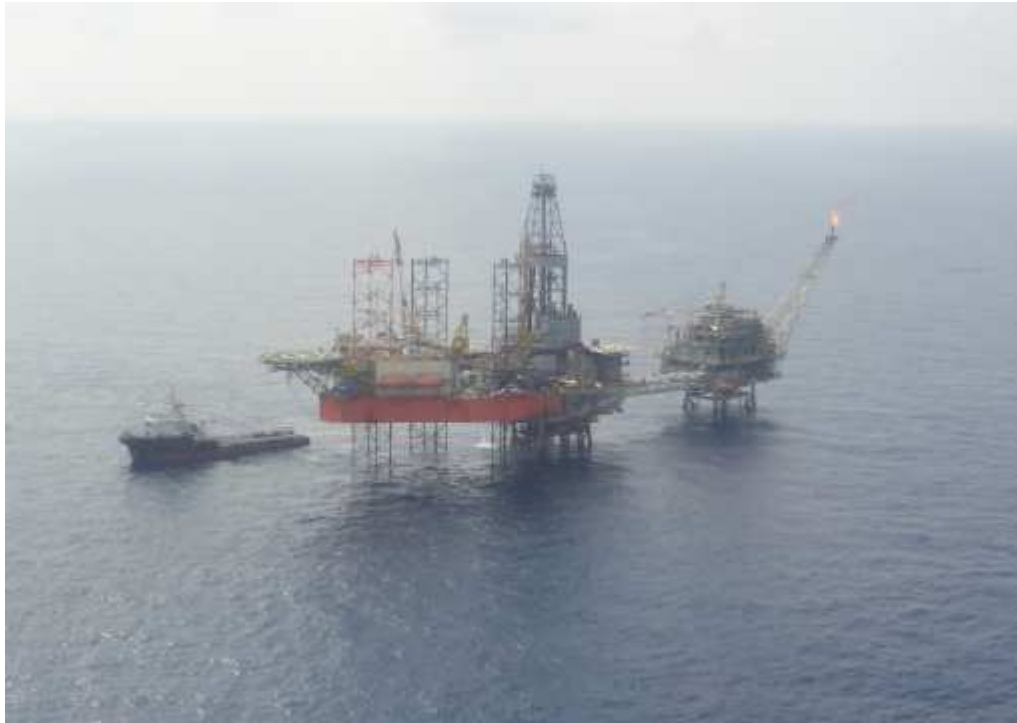
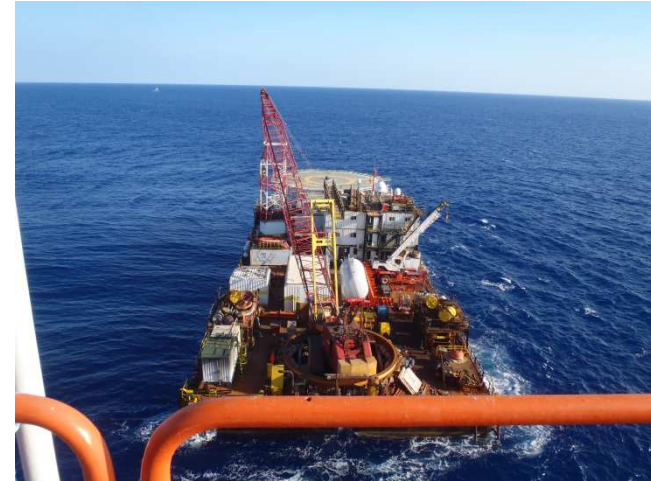
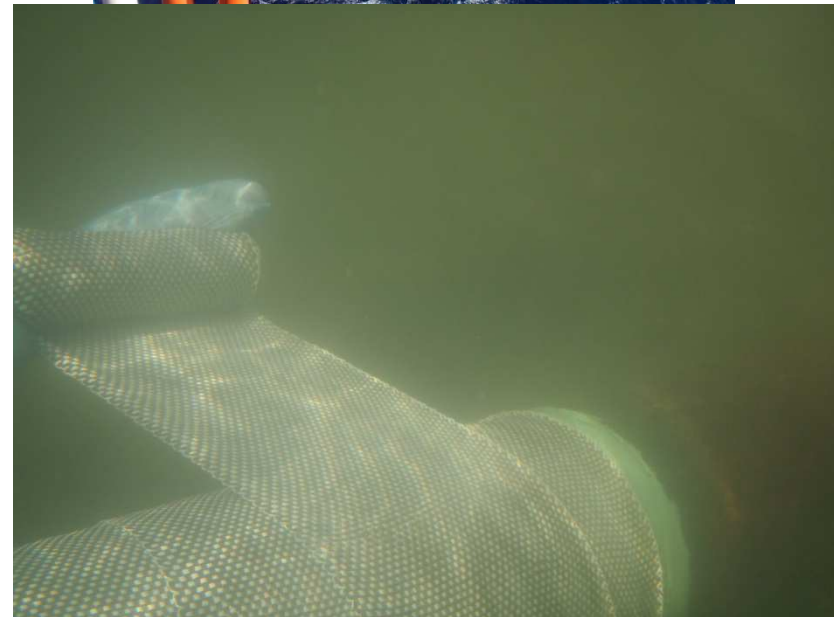
Field Case Studies

- Offshore pipeline west coast USA
- 6" carbon steel
- 14 linear feet total repair
- Multiple defect locations with external corrosion
- Design pressure of 2,130 psi
- Fully repaired via Viper Skin™ composite repair system
